State of Utah  
DEPARTMENT OF NATURAL RESOURCES  
DIVISION OF OIL, GAS AND MINING

RE: Site Inspection, Holliday Construction, Lime Ridge Limestone Quarry,  
S/037/081, San Juan County, Utah

Date of Inspection: April 21, 1994  
Time of Inspection: 0910 - 1405  
Conditions: Sunny, hot  
Participants: Jerry Holliday, Holliday Construction; John Blake, Division of State  
Lands and Forestry; Travis Jones and Tony Gallegos, DOGM

Purpose of Inspection: Measure approximate disturbed area and inspect the site.

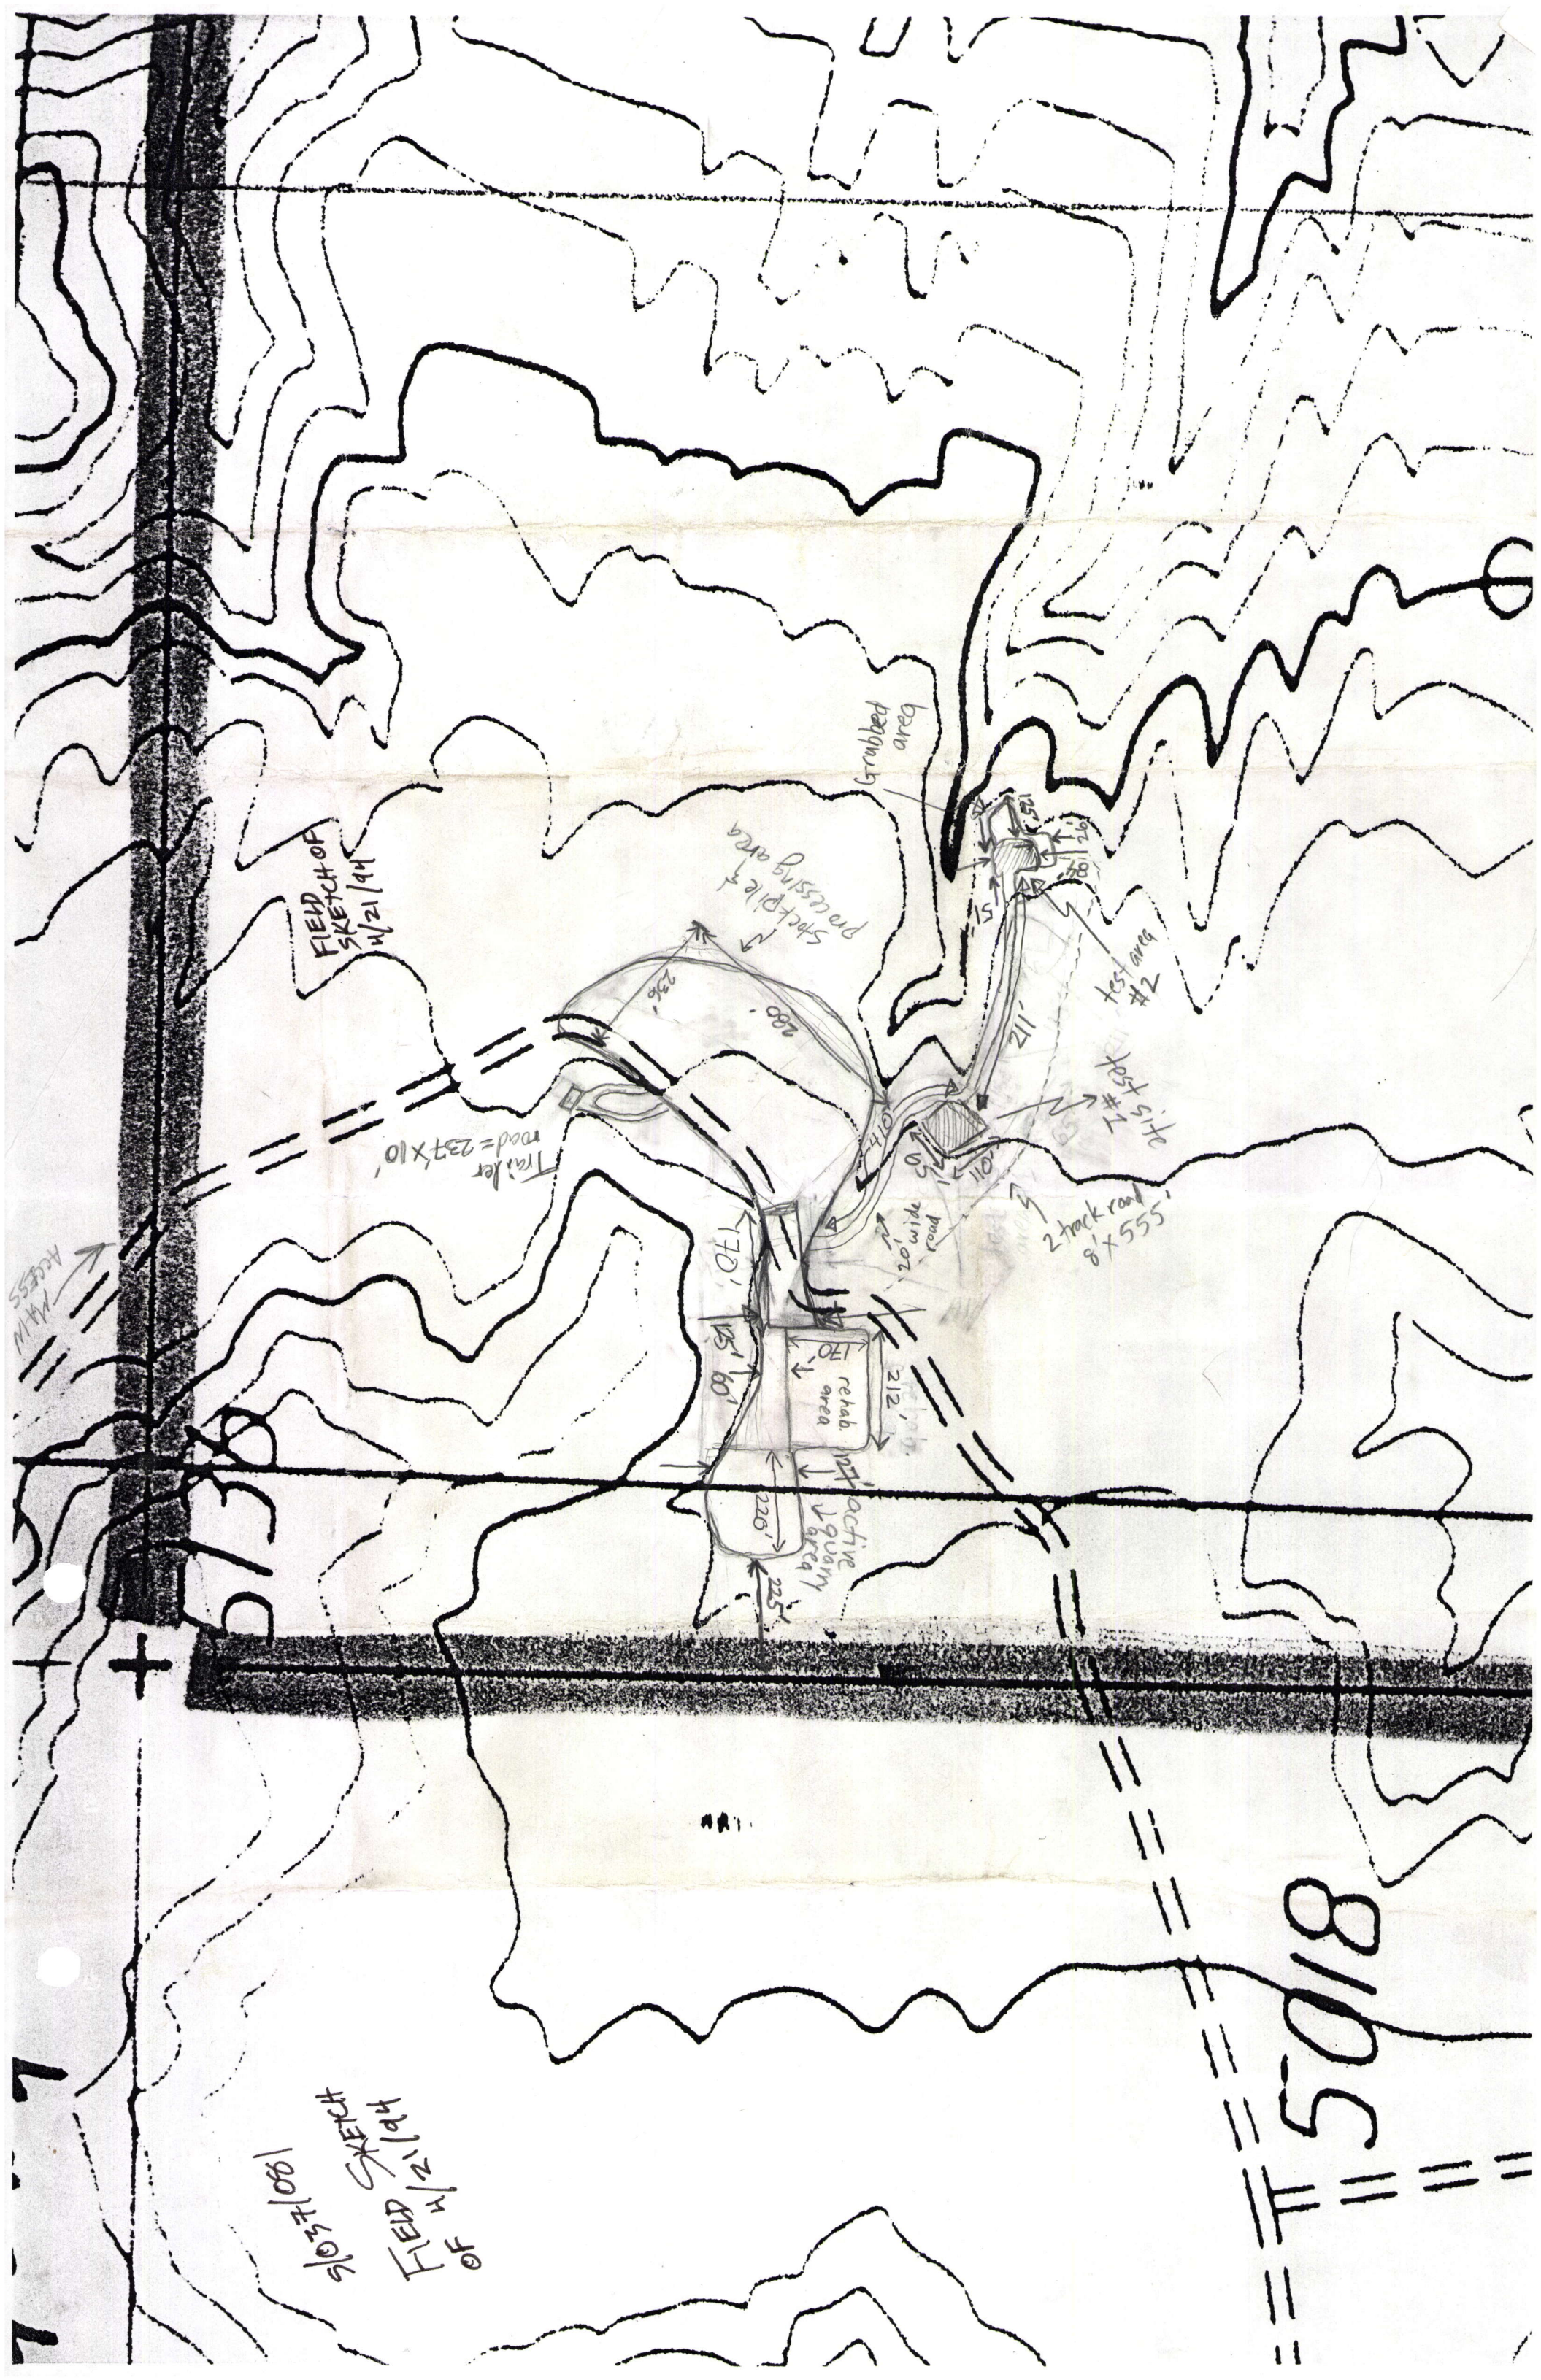
FIELD SKETCH OF  
4/21/94

road = 237' x 10'

2 track road  
8' x 555'

rehab. area

quarry area
